Early Failures Utilizing the Photodynamic Bone Stabilization System in Pathologic and Impending Fractures

John Krumme, MD^{1,2}; Ashley MacConnell, MD³; Matthew Wallace, MD⁴; Albert Aboulafia, MD⁴; James Jelinek, MD¹; Brock Adams, MD^{1,2}; Robert Henshaw, MD^{1,2}

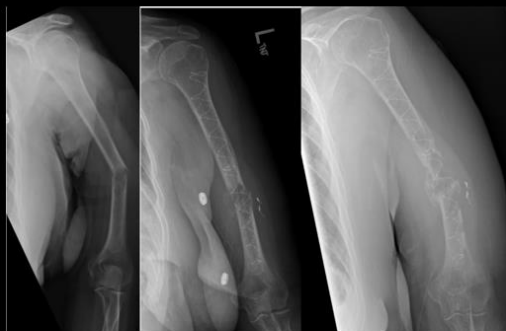
Failures due to Progression of Disease

Renal Cell Carcinoma Distal Humeral Fracture

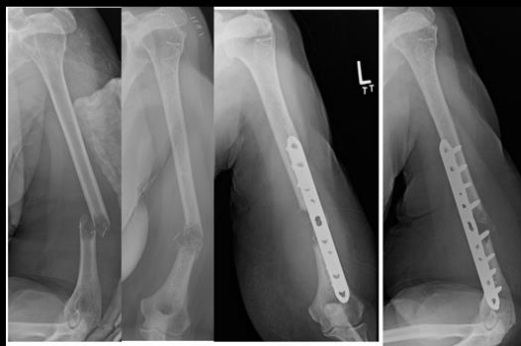
Renal Cell Carcinoma Distal Humeral Lesion Revision with a Locking Compression Plate

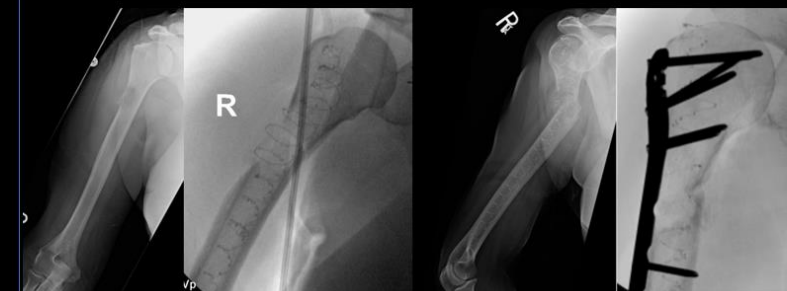
Mechanical Failure

Implant Fracture in a Proximal Humeral Lesion from Breast Cancer
